HILINE CORROSION PROTECTION

Crosswise moveable parking pallets

ParkBoard PQ

Dokument: 589 Stand:

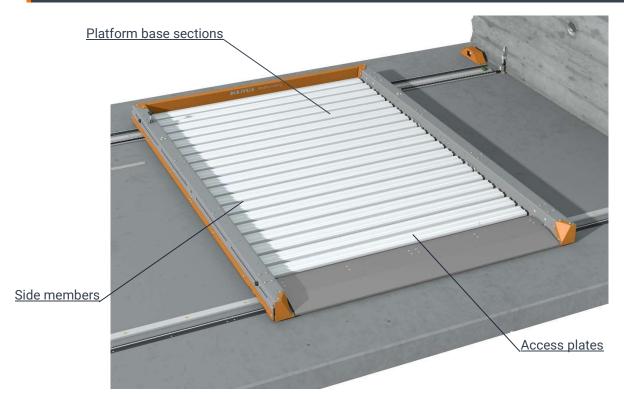
1. System specitic corrosion protection

Platform base sections:

StandardGrip:

Hot galvanized according to DIN EN ISO 1461, layer thickness min. 55 µm.

Side members:

Hot galvanized according to DIN EN ISO 1461, layer thickness min. 55 μm .

Acces plates:

Cross members:

Hot galvanized according to DIN EN ISO 1461, layer thickness min. 55 $\mu m. \,$

Rail system:
