HILINE CORROSION PROTECTION

Parker

1. System specitic corrosion protection

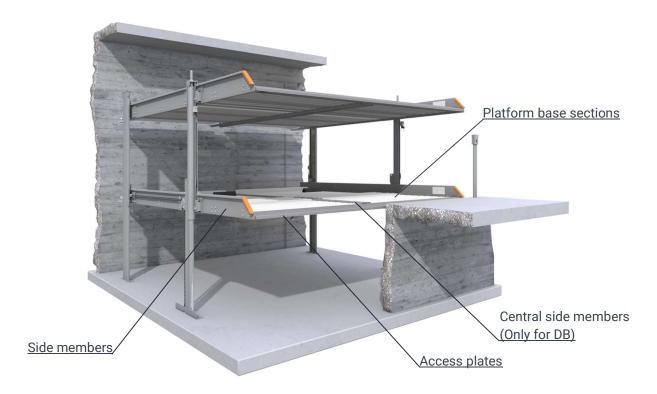
Platform base sections, coverplates and poss. platform extensions:

StandardGrip:

Hot galvanized according to DIN EN ISO 1461, layer thickness min. 45 µm.

EasyWalk:

Hot galvanized according to DIN EN ISO 1461, layer thickness min. $45 \mu m$.

AluLongLife:

Extruded aluminium section according to EN AW-6106 T6 (AlMgSi0,5).

Side members and poss. extensions:

Hot galvanized according to DIN EN ISO 1461, layer thickness min. 55 μm .

Central side members (only for DB):

Hot galvanized according to DIN EN ISO 1461, layer thickness min. 55 μ m. Central side members with additional gray powder coating (epoxide/polyester base) RAL 7040, dry film thickness approx. 60-80 μ m.

Cross members:

Hot galvanized according to DIN EN ISO 1461, layer thickness min. 55 μ m.

Other steel components:

Shot-blasted (particle cleanliness SA 2.5) and grey powder coating (epoxide/polyester base) RAL 7040,

dry film thickness approx. 60 - 80 μm.
